EXHIBIT “A-2”

Electrolux / General Electric Design

The subject dryer designs employed by Electrolux in their 5.7/5.8 Cu. Ft. dryers were evaluated and the following hazards related to the risk of fire were identified:

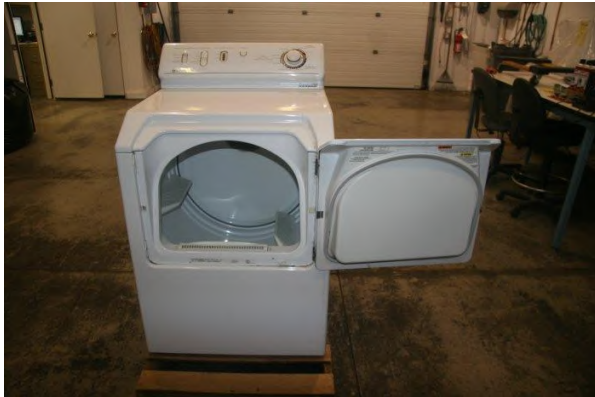
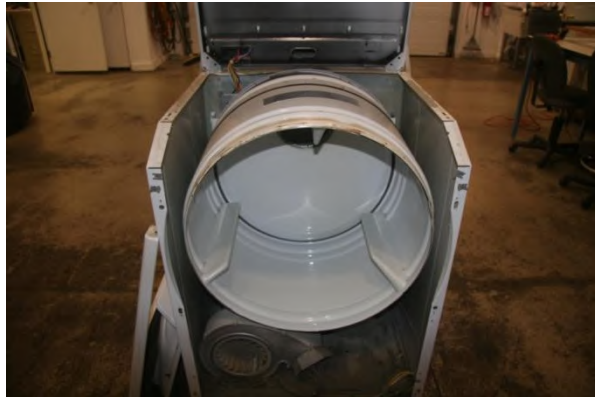
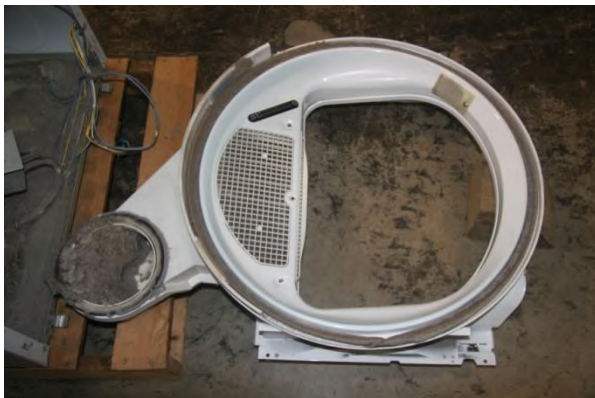
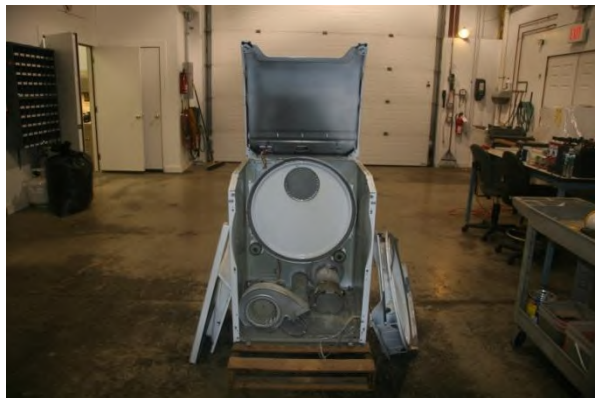
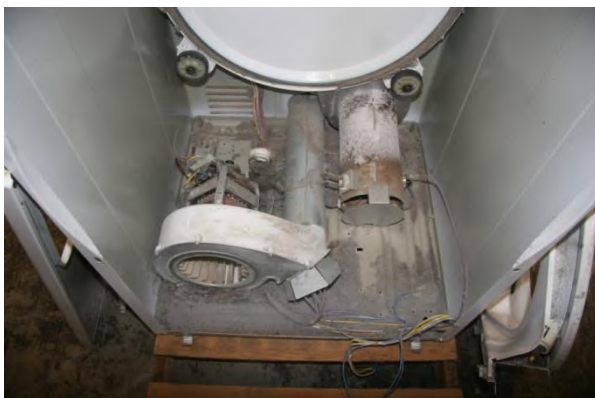
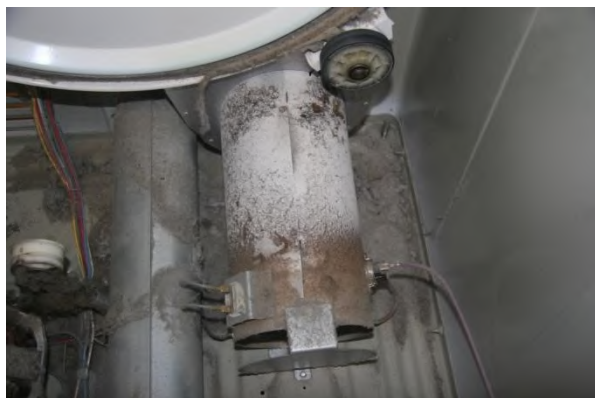
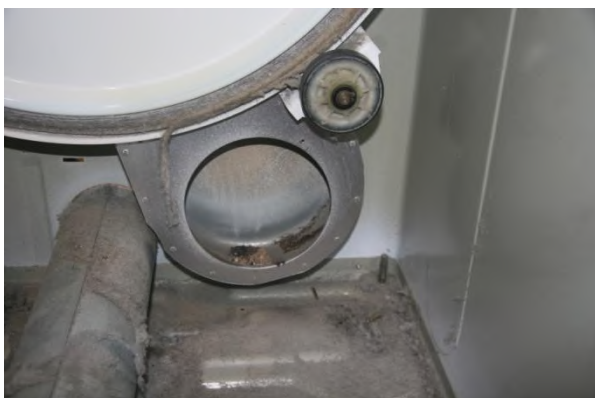
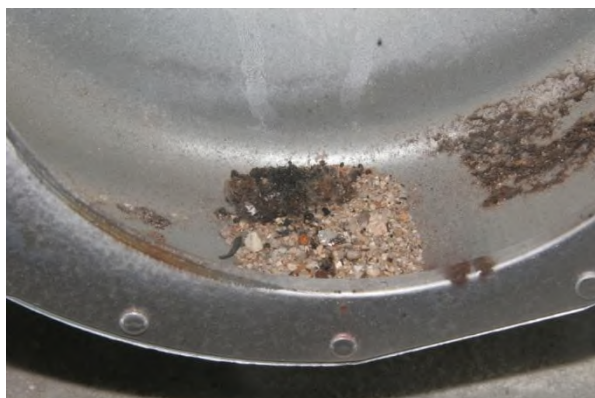
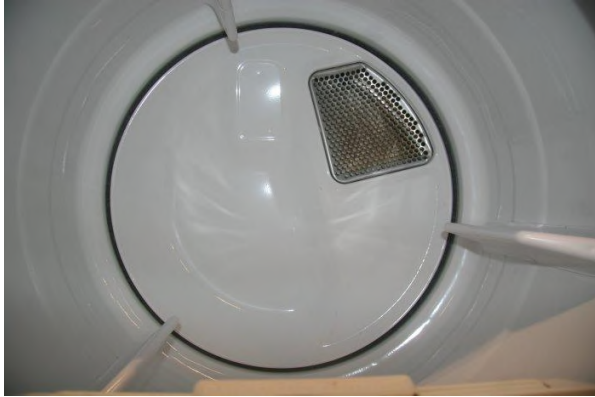
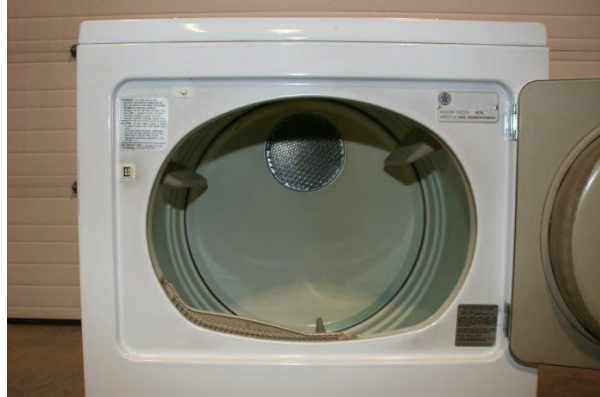
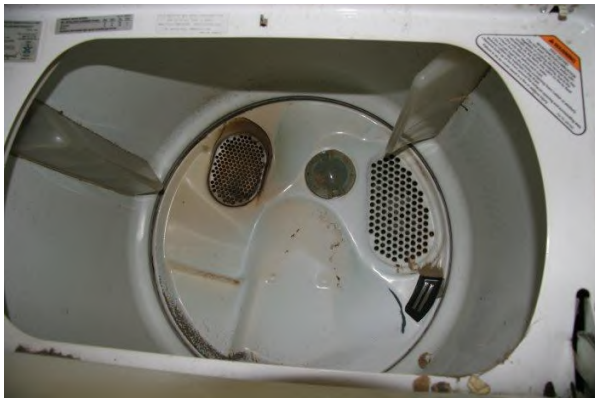
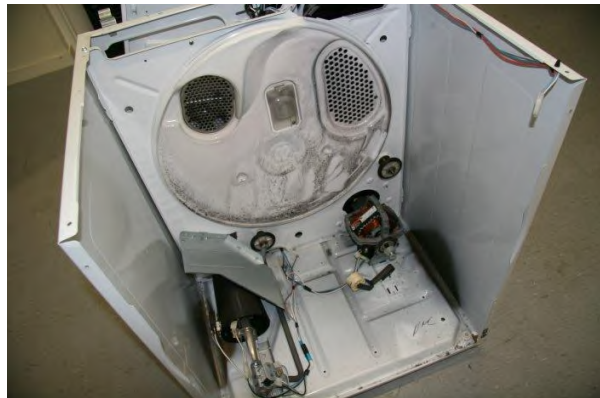
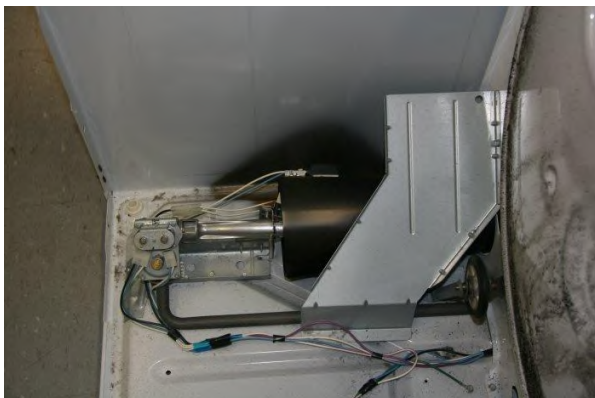
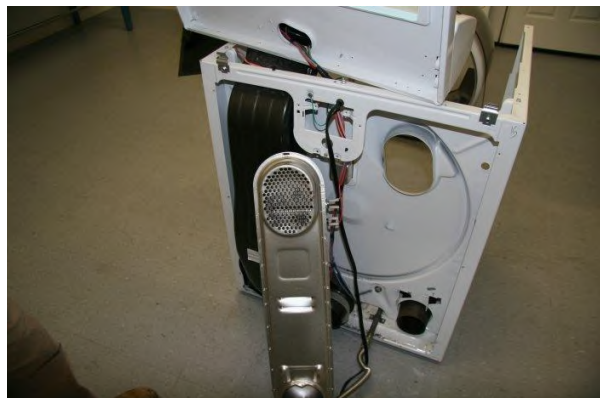
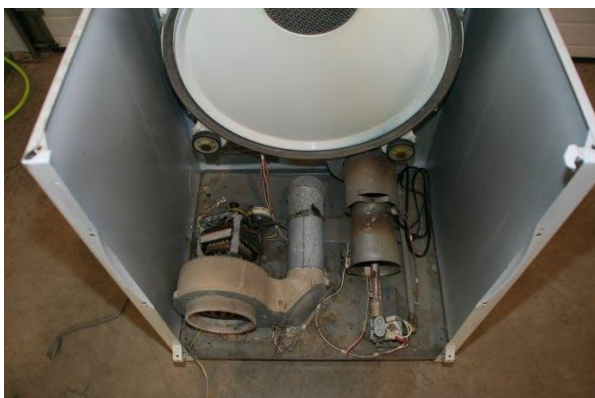
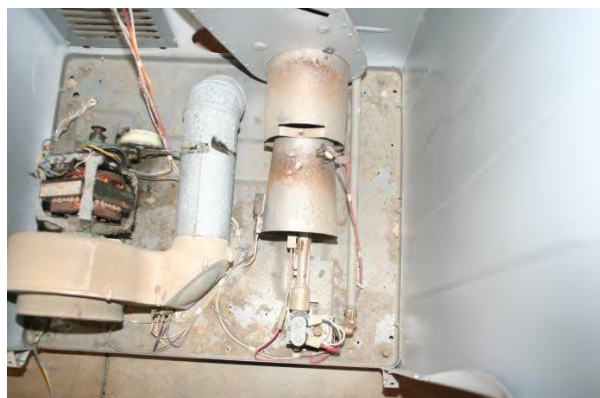
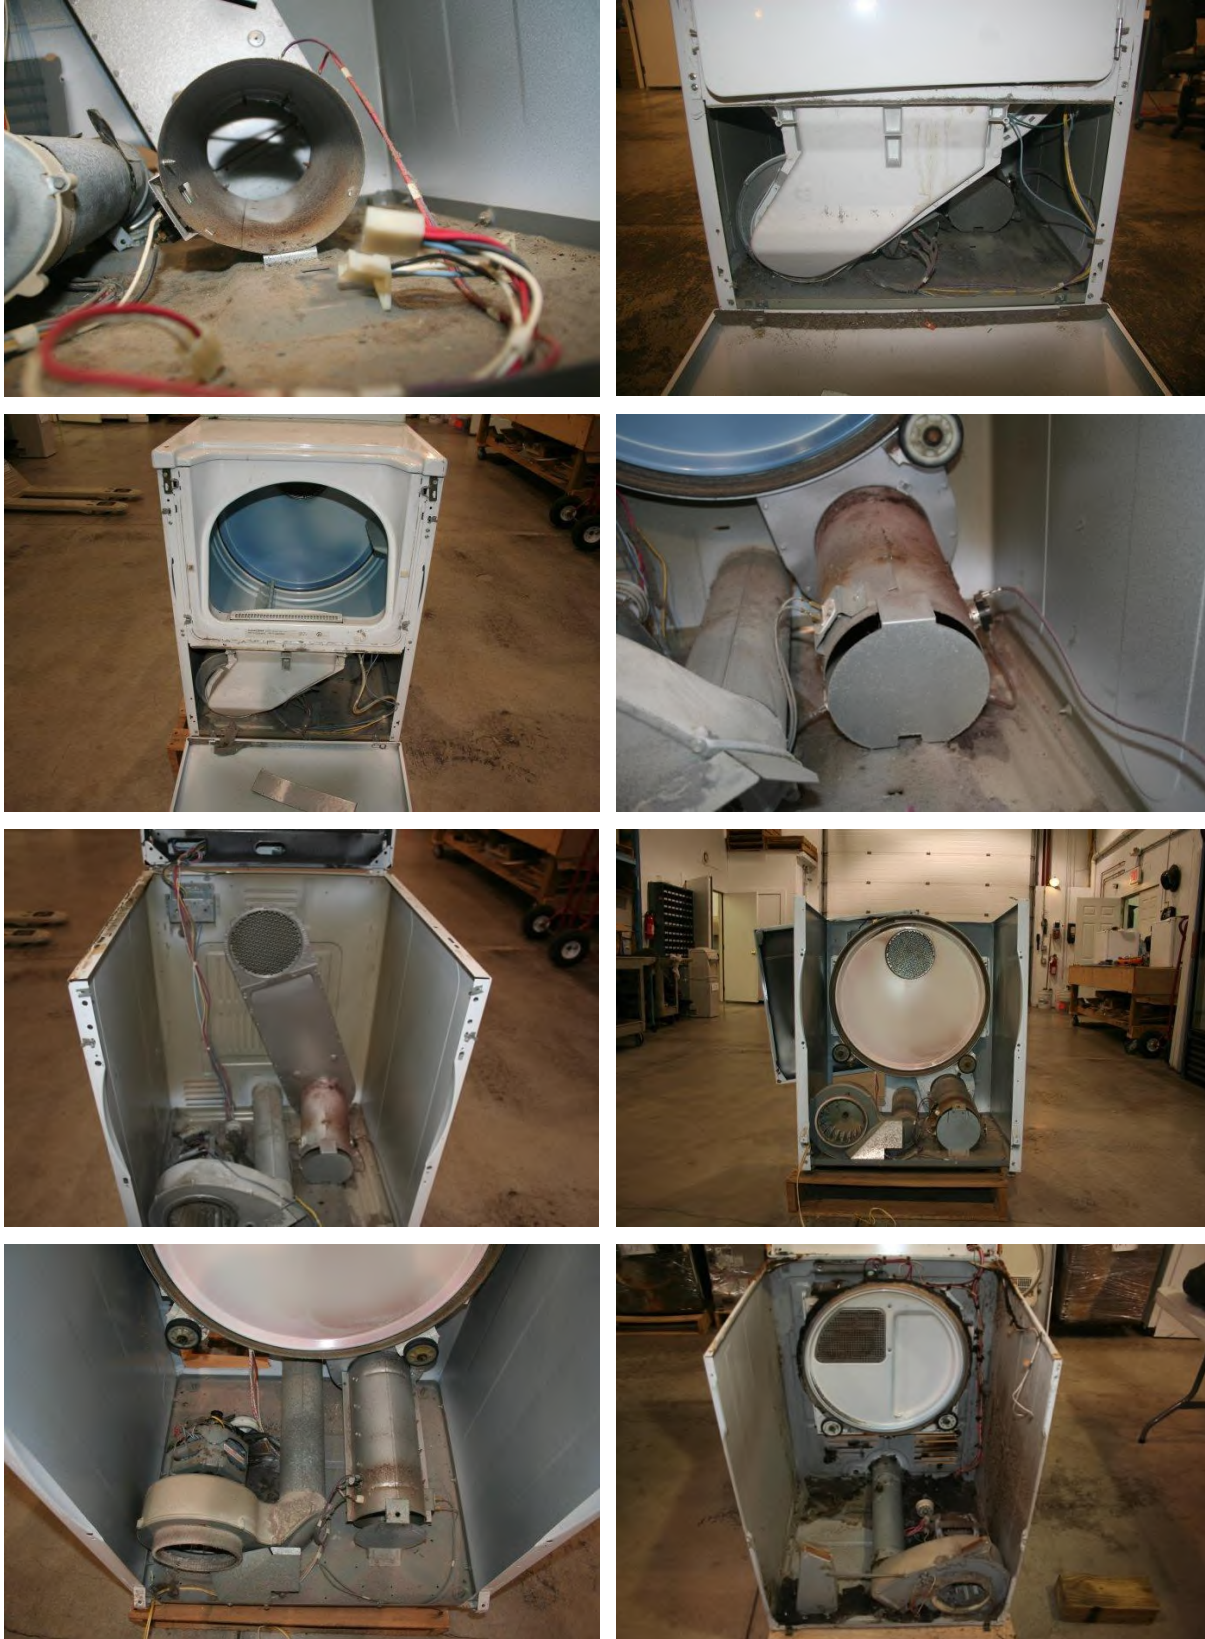
Photos of Whirlpool & Maytag Exemplars

The Wright Group has examined numerous dryers of other alternative designs by other manufacturers as well as the Electrolux Ball-Hitch design. It is not being contended that the alternative design of dryers accumulate less lint in the cabinet, but rather that the lint that does specifically accumulate behind the drum near the heat source, where it is most likely to be ignited by the gas burner or heating element. Attached are demonstrative photos showing the interior of Whirlpool and Maytag clothes dryer that employ the Bulkhead design. It should be noted in these photographs that, while lint can accumulate inside the any dryer cabinet, in the Bulkhead design it does not accumulate in the same position in areas where the lint is at risk of contacting the heat source. Also, the alternative Bulkheads designs do not have a void space behind the drum like those found in the subject Electrolux design, where lint has been shown to collect. Please refer to earlier sections of our report for views of the exemplar Electrolux dryers for comparison to these other manufacturers' designs.

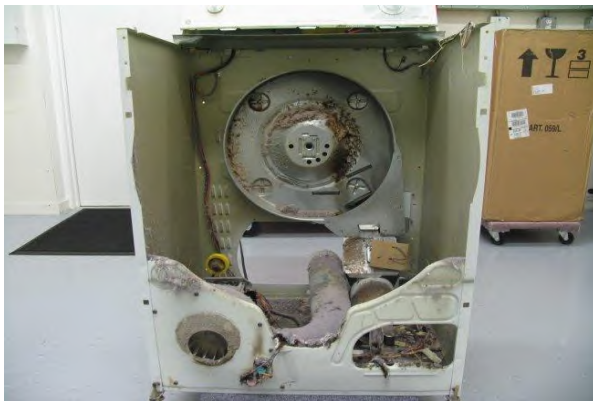
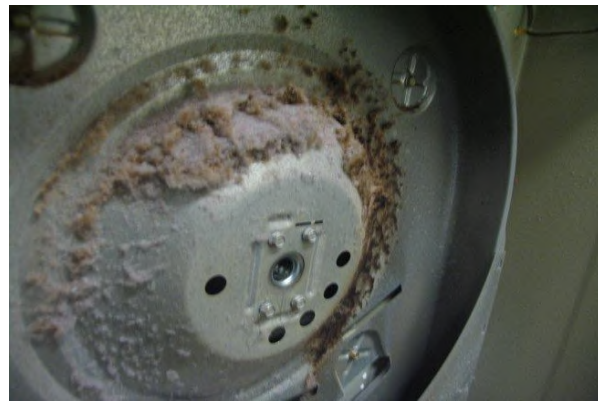
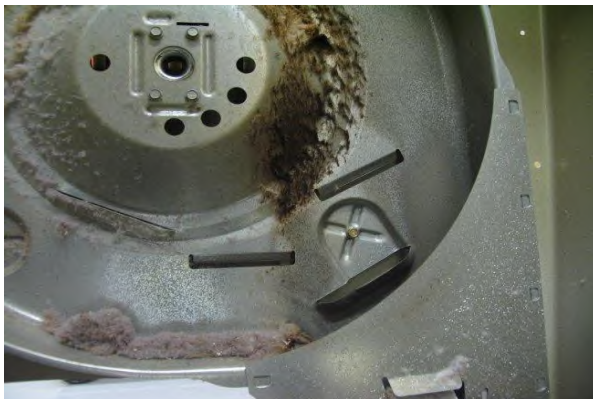
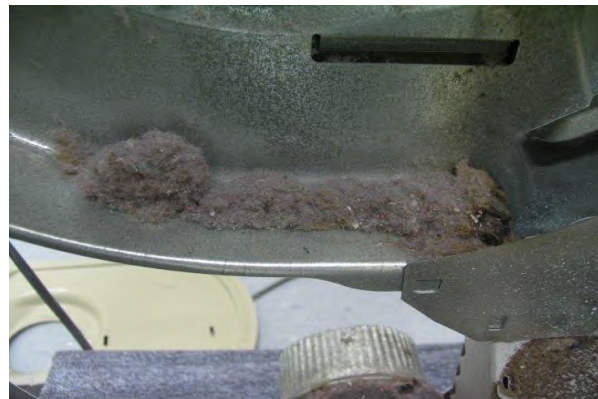
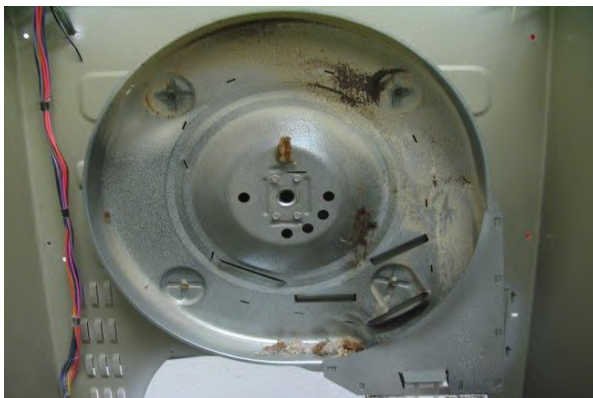
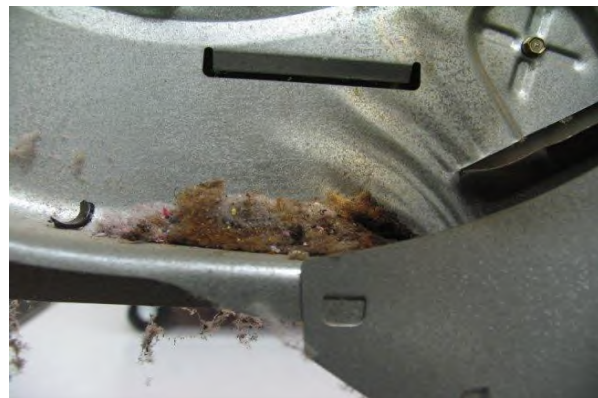
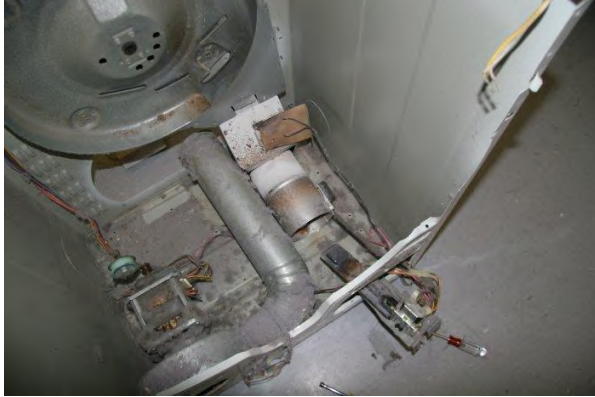
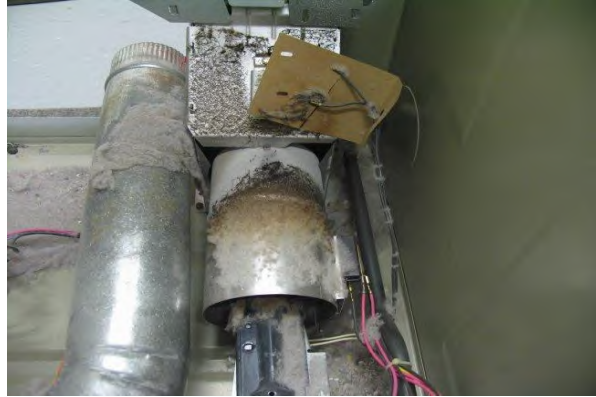
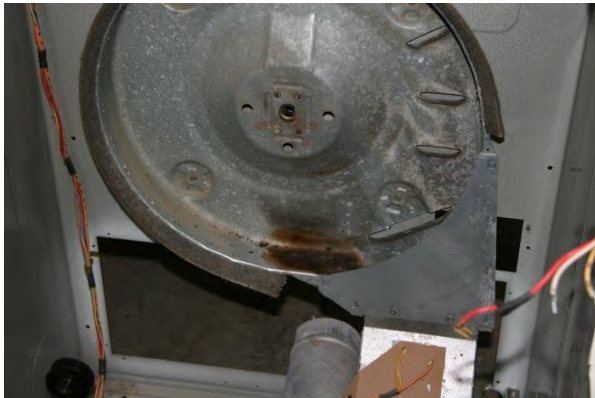
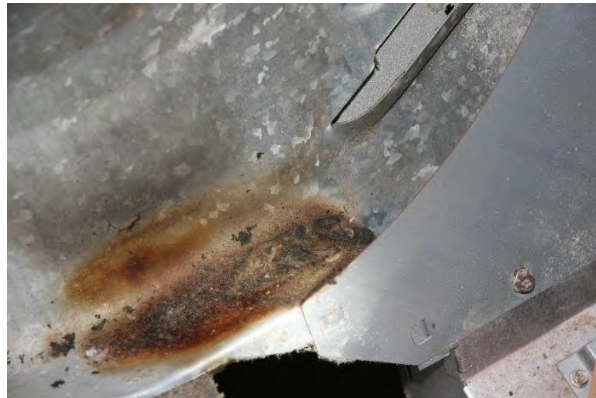
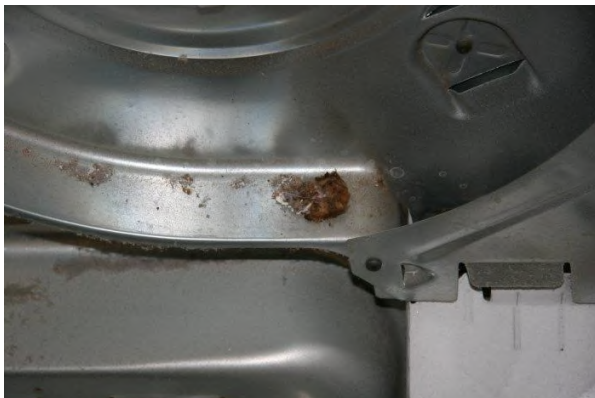
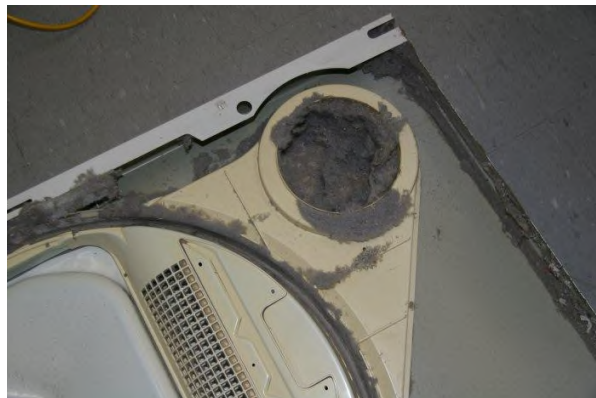
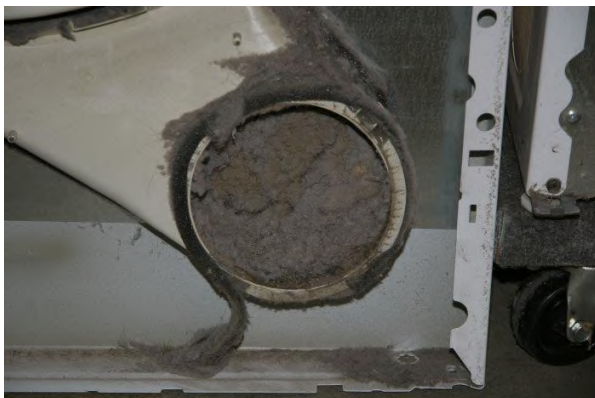
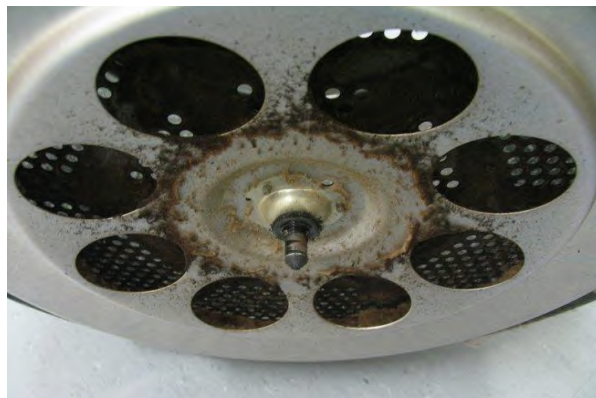
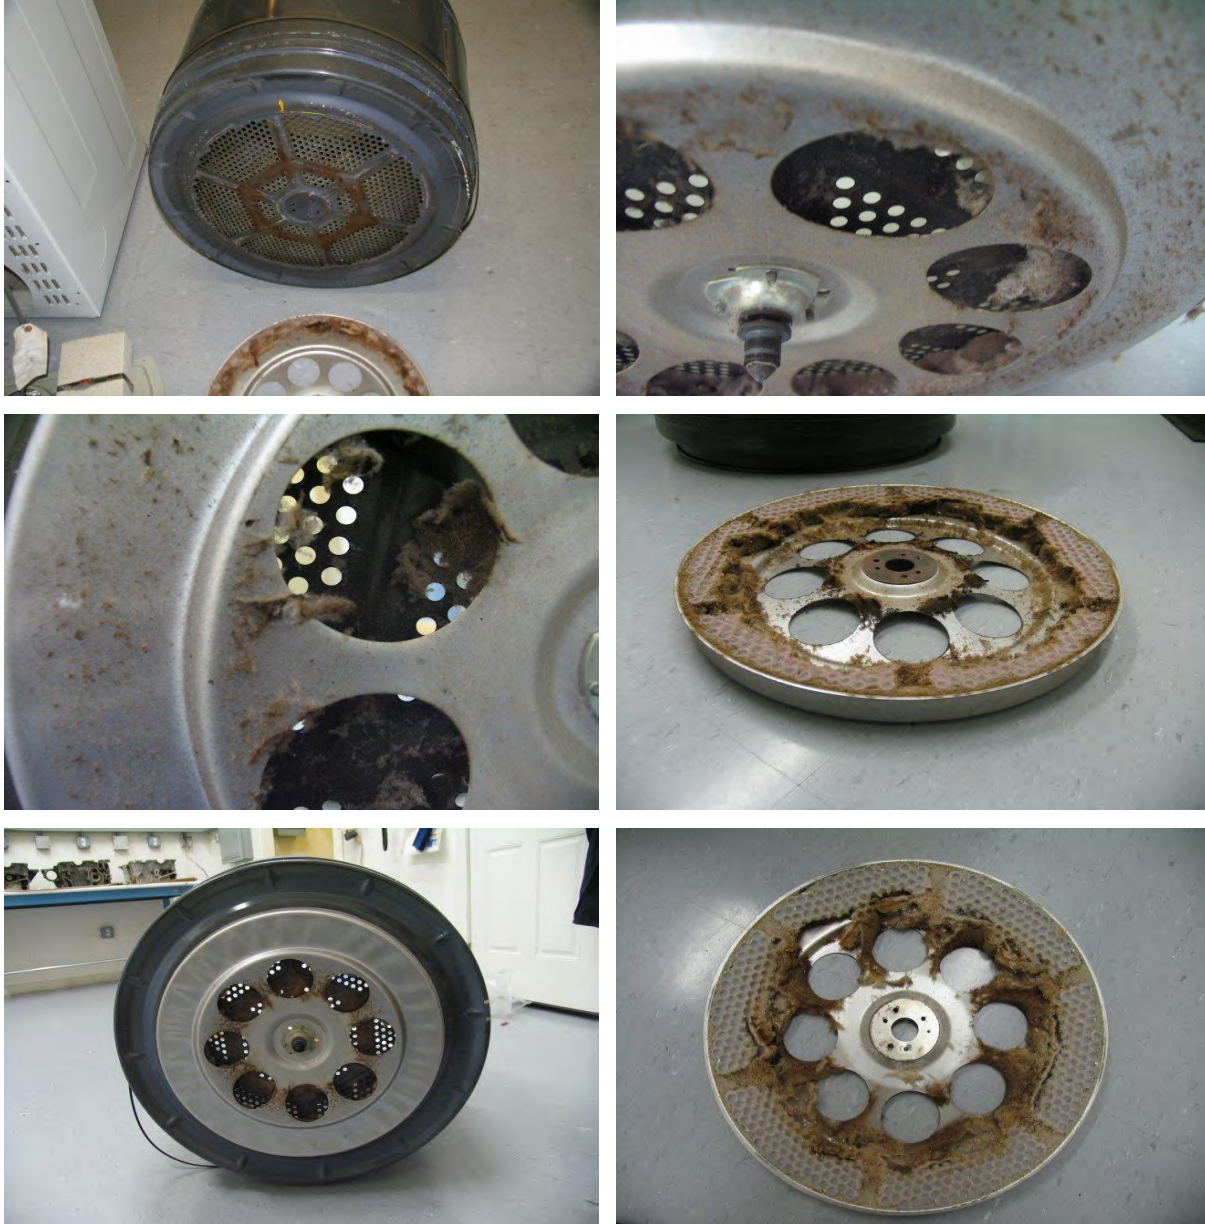
Photos of GE Exemplars with Lint

Also included for comparison are photographs of the Ball-Hitch design employed by GE, CAMCO and MABE, which share many features with the subject Electrolux dryer design. It should be noted in this substantially similar design, quantities of lint are regularly observed in the same area to the rear of the drum and in proximity to the heat source. These areas include the rear of the drum, the interior of the heat shield/baffle that attaches to the rear of the drum and in proximity to the vertical heat duct in the gas dryers and in proximity to the heating element in the heater pan of the electric dryers.

Comparison of the various designs of dryers revealed that the Electrolux/GE Ball-Hitch design types of dryers accumulated substantially more lint in critical areas where it is more probable that a fire will originate than in the alternative designs used by Whirlpool and Maytag Bulkhead designs. This lint accumulation was particularly noticeable in areas at or near the heat sources, such as behind the drum of the Electrolux/GE dryers.

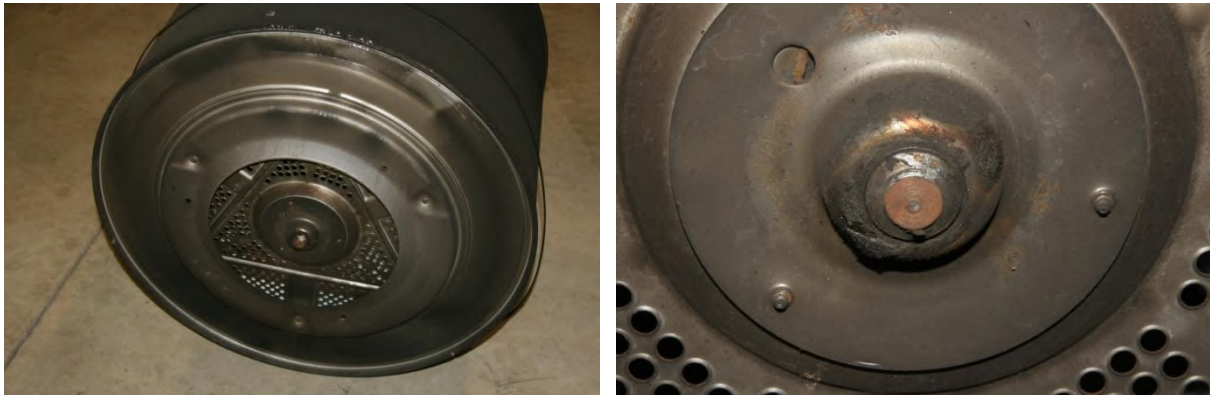
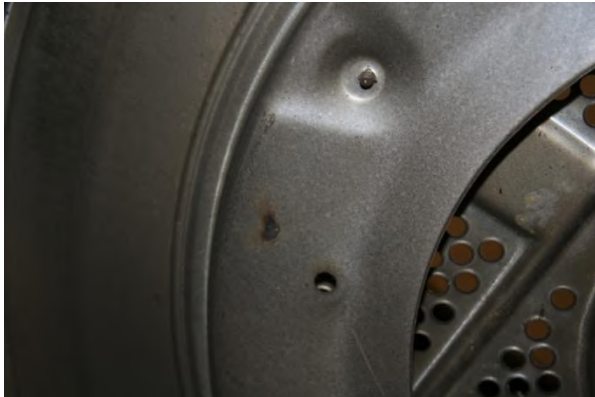
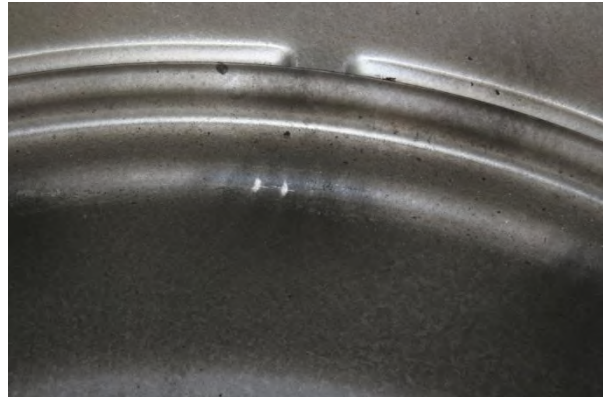
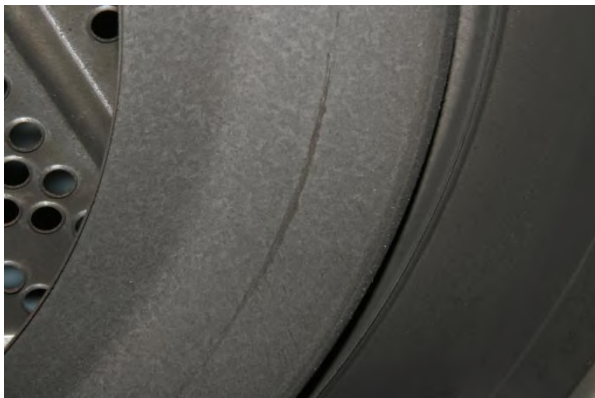
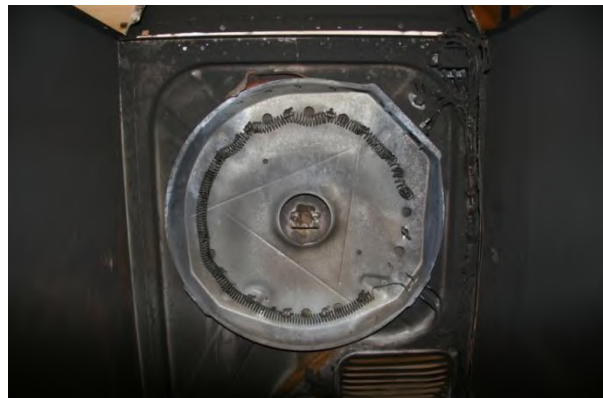
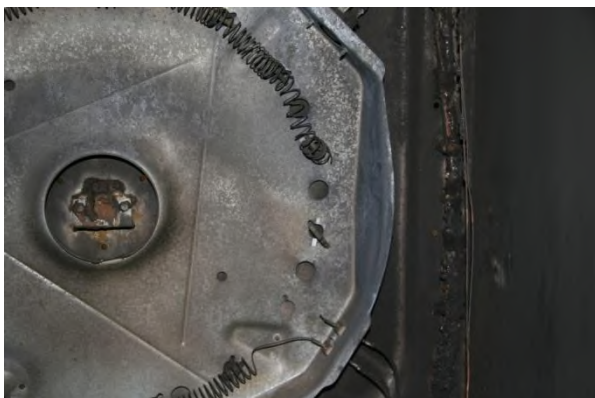
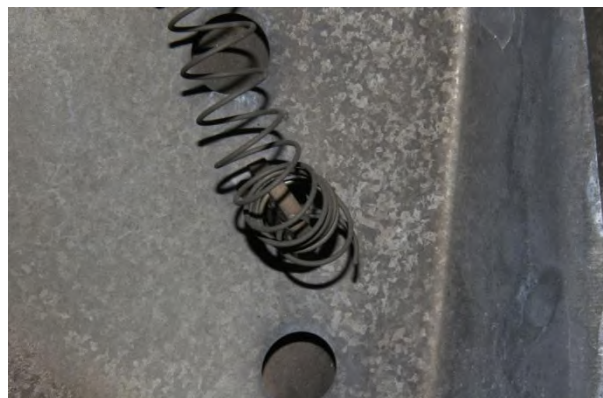
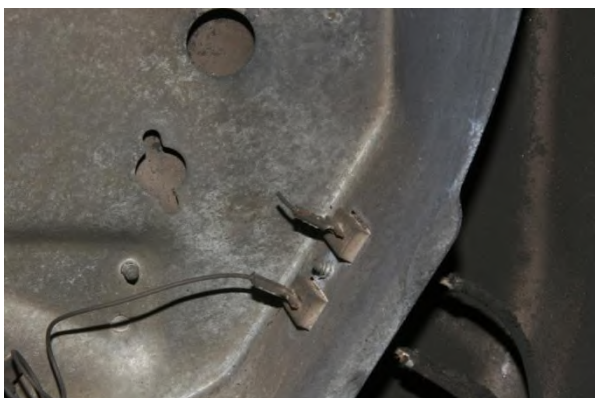
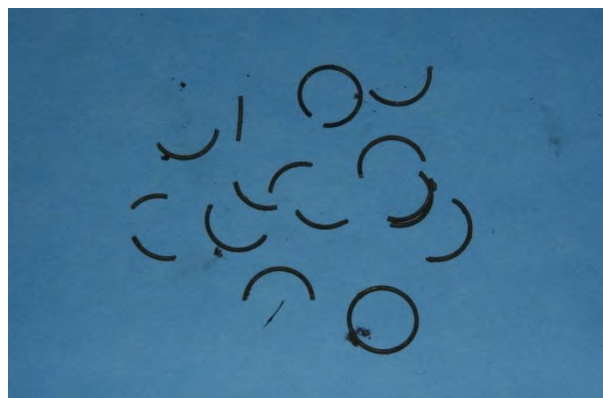
Example of Damage Related to a Bearing Failure

The first is a bearing failure that results in fire when the single rear bearing assembly that suspends the drum from the center of the heater housing fails, causing the rear of the metal drum and its clothing load to shift from its original position. When this occurs while the dryer is operating, the metal baffle/heat shield attached to the rear of drum contacts the energized heating element located approximately one inch from the rear of the drum, which results in a ground fault. This electrical short emits hot molten metal into the cabinet in the area at the rear of the drum. Any lint accumulated on the rear of the drum or within the cabinet can be ignited. The hot molten metal can also pass through the perforated ventilation openings in the rear of the drum and ignite the clothing load, particularly if the load is dry. The ability for the molten metal to be drawn into the rear of the drum is compounded by the negative pressure caused by the operating blower fan assembly, pulling air from the direction of the heating element behind the drum, into the clothing and toward the lint filter assembly at the front of the drum. It should be noted that other electric dryers of the other manufacturers' design types do not have their heating element located in this same location. Instead they are located in a metal duct in the cabinet below the drum. This eliminates the possibility of a bearing failure of any caliber to allow the drum to contact the heating element under any circumstances.

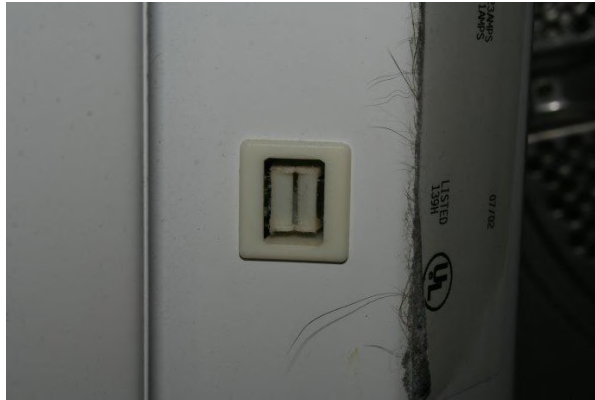
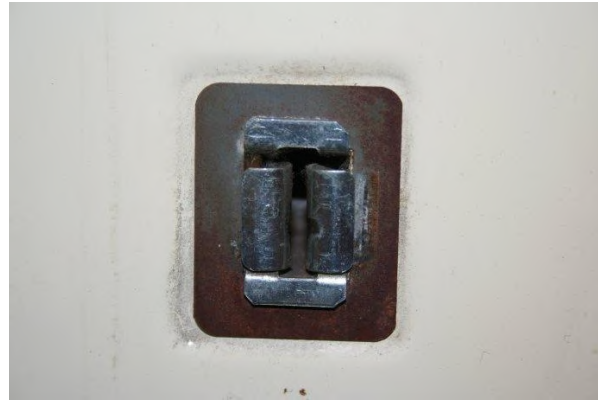
The door latch assembly on the unburned and burned dryers indicates that the latch pin is manufactured out of steel and mechanically fastened to the door assembly. The latch pin catch, which is located in the front of the cabinet, has the majority of its components manufactured out of plastic. When attacked by fire, this plastic melts and burns away. The result of the decomposition of the door latch base allows the latch mechanism to be ineffective at keeping the dryer door closed. This results in the dryer door being able to open during the fire event. When the dryer door opens, the fire escapes out of the dryer drum location.

Replacing the plastic door latch with an all steel assembly

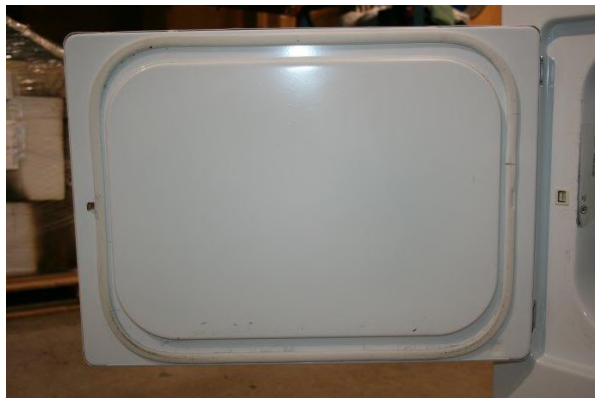
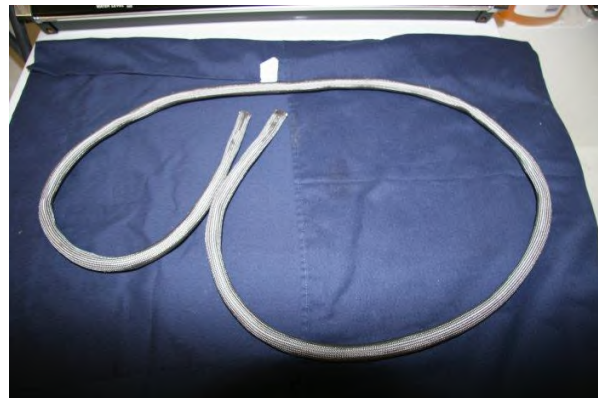
The exemplar dryers analyzed indicate that the door gasket used to seal the door in the front of the dryer opening fails when it is subject to fire. The gasket melts and burns away and allows fire to escape from the drum after the clothes load is ignited.

Replacing the plastic door gasket with a flameproof fibrous gasket

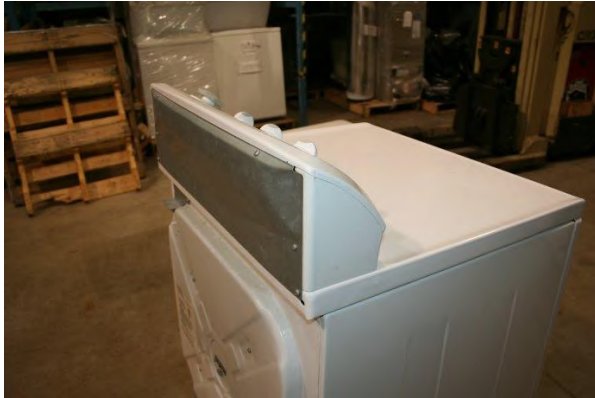
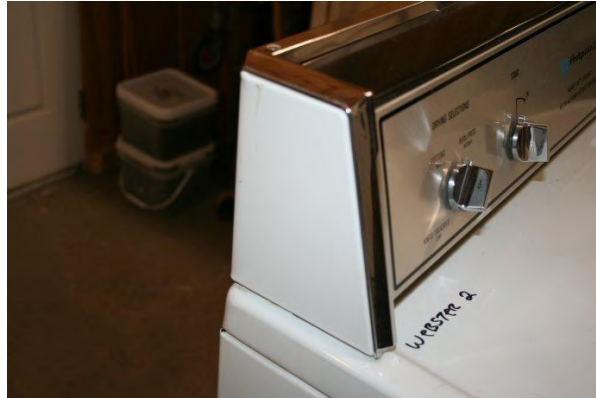
In viewing numerous dryers involved in fires, we have observed many instances where the fire has been contained primarily to the drum and we have also inspected dryers where the fire has escaped out of the drum due to the failed gasket and door latch assembly. The lint at the rear of the dryer heater housing or diffuser has caught on fire and the fire has traveled through the rear of the drum and ignited clothes. In some instances, the fire was partially contained to the dryer assembly and other instances the fire was able to escape the dryer assembly through the front panel's door opening and the penetrations in the top of the cabinet at the control console

Eliminating the use of plastic end caps and related combustible components at the control console, or replacing them with steel

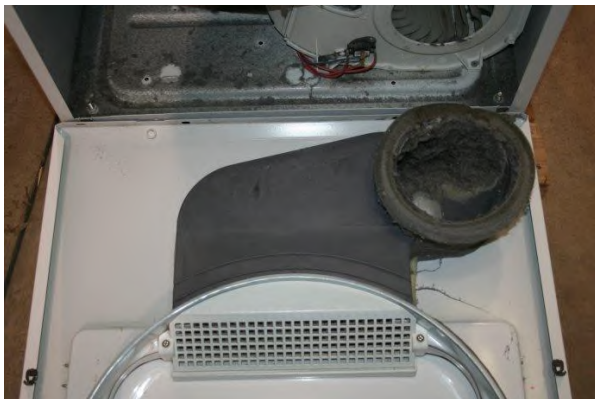
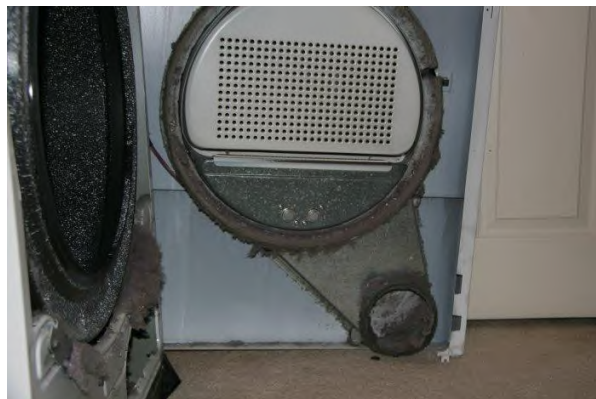
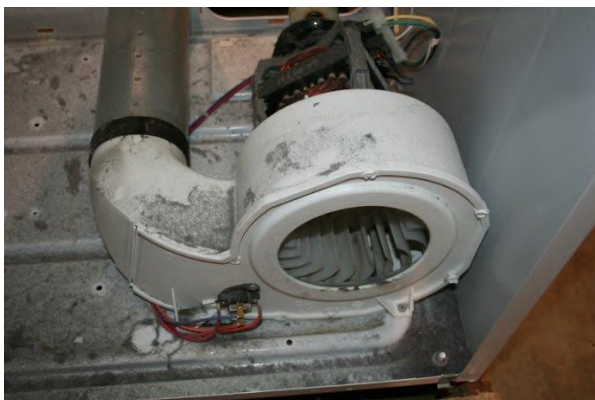
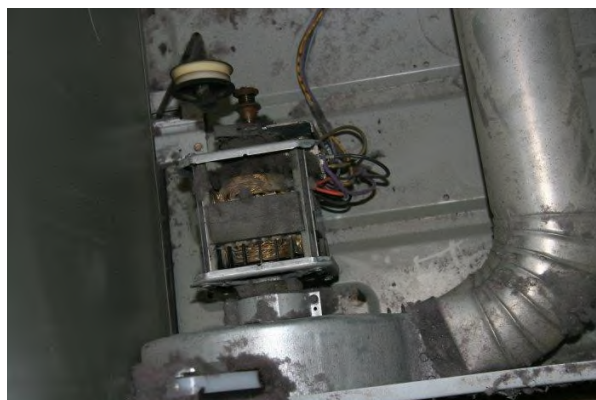
location. Fire also escaped the cabinet and spreads to nearby combustibles as the plastic trap duct and blower housing catch fire, causing the melted and burning plastic to flow from the cabinet to the exterior where this burning plastic can ignite other materials adjacent to the dryer.

Replacing the plastic trap duct and blower housing with steel components

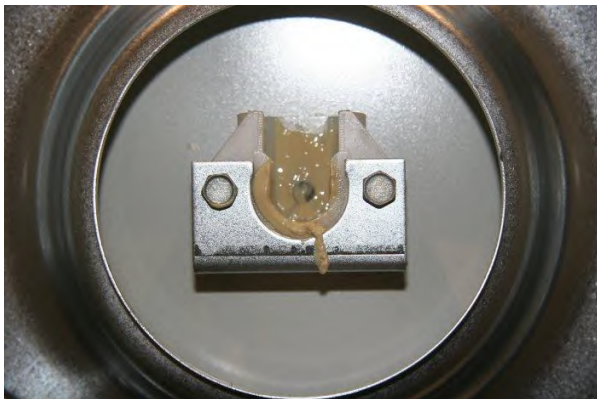
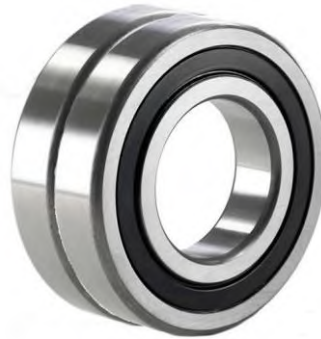
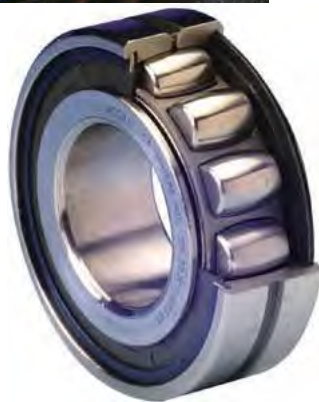
2. **Failure of the Drum Bearing Assembly:** This fire hazard is limited to electric models only. The rear of the drum is supported by a single point bearing assembly consisting of a metal ball pivot affixed to the center of the drum which rotates in the hitch assembly, consisting of a plastic or nylon bearing material supported by a metal bracket, affixed to

the rear of the cabinet at the center of the heater housing/diffuser assembly. If the plastic bearing material fails, the metal pivot rotates directly against the metal bracket of the ball/hitch resulting in scoring of the pivot shaft. Over a period of time, the scoring weakens the pivot until it is severed or breaks, allowing the drum to shift. The rear of the metal drum and/or attached heat shield is normally located less than one inch from the heating element, but under these circumstances the shifted drum can contact the heating element. If the heating element is energized, a ground fault occurs between the heating element and rear metal drum and/or baffle. The heating element typically breaks and a section of the heating element in the form of molten metal slag is released. Since the dryer is operating at the time, the airflow is being pulled into the rear of the drum, drawing this hot slag into any lint collected at the rear of the drum and/or into the clothing load, resulting in a potential fire. In addition, the shift in the drum will allow for lint that collects within the baffle/heat shield and on the rear of the drum to migrate closer to the heating element or even come into direct contact with the heating element and be ignited.

Replacement of the plastic bearing material with steel bearing materials

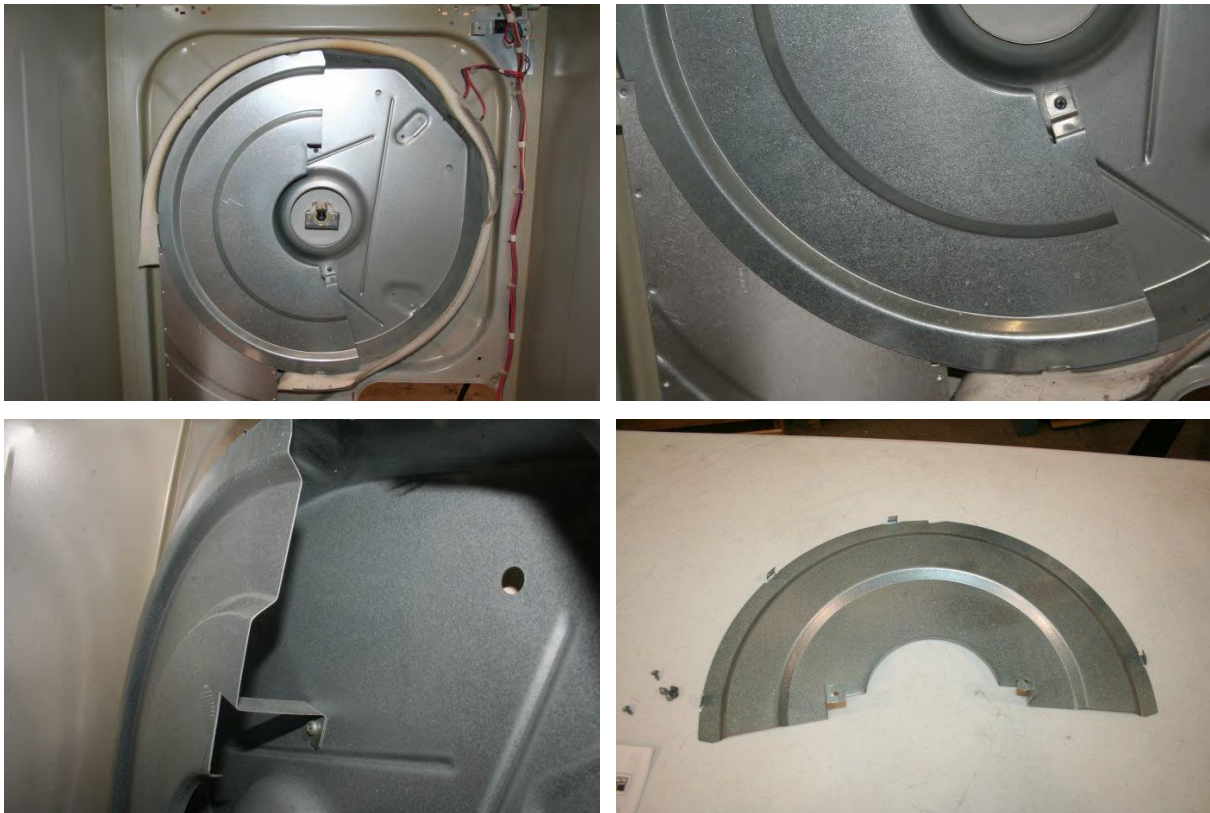
Electrolux Manufactured Guard in GE Gas Dryer Model DVL223GB5WW

The gas dryers manufactured by Electrolux for General Electric contained a similar guard that was used as the primary basis of this design. This guard was only installed in gas GE models, not in Frigidaire models. The Wright Group improved the design by enclosing the lower half, below the drum pivot opening and adding a baffle to prevent the ignition of lint that collects in the lower half of the heat diffuser. The exemplar dryer below was a General Electric gas dryer manufactured by Electrolux in December 2003.

The potential for a fire to be caused by the ignition of lint that collects in the diffuser by the burner flame is remedied by the installation of a very simple guard manufactured out of sheet metal. The concept is to simply form a guard that lengthens the vertical heat duct from where it enters the diffuser at the 7 o'clock position and extend it up to the 1 o'clock position. Any of the lint that accumulates at the 6 o'clock position is blocked from falling into the vertical heat duct/burner tube by the guard, even if the lint accumulates to several inches in depth. Conversely, if any lint accumulates on the gas burner assembly and changes the flame characteristics resulting in a flame that reaches up into the diffuser pan, the flame cannot contact any lint accumulated at the 6 o'clock position. The guard forms an internal duct through which the air velocity remains higher than within the larger area of the diffuser pan, so lint cannot accumulate within the duct formed by the guard. The addition of a baffle to the right side of the shield creates an air gap to

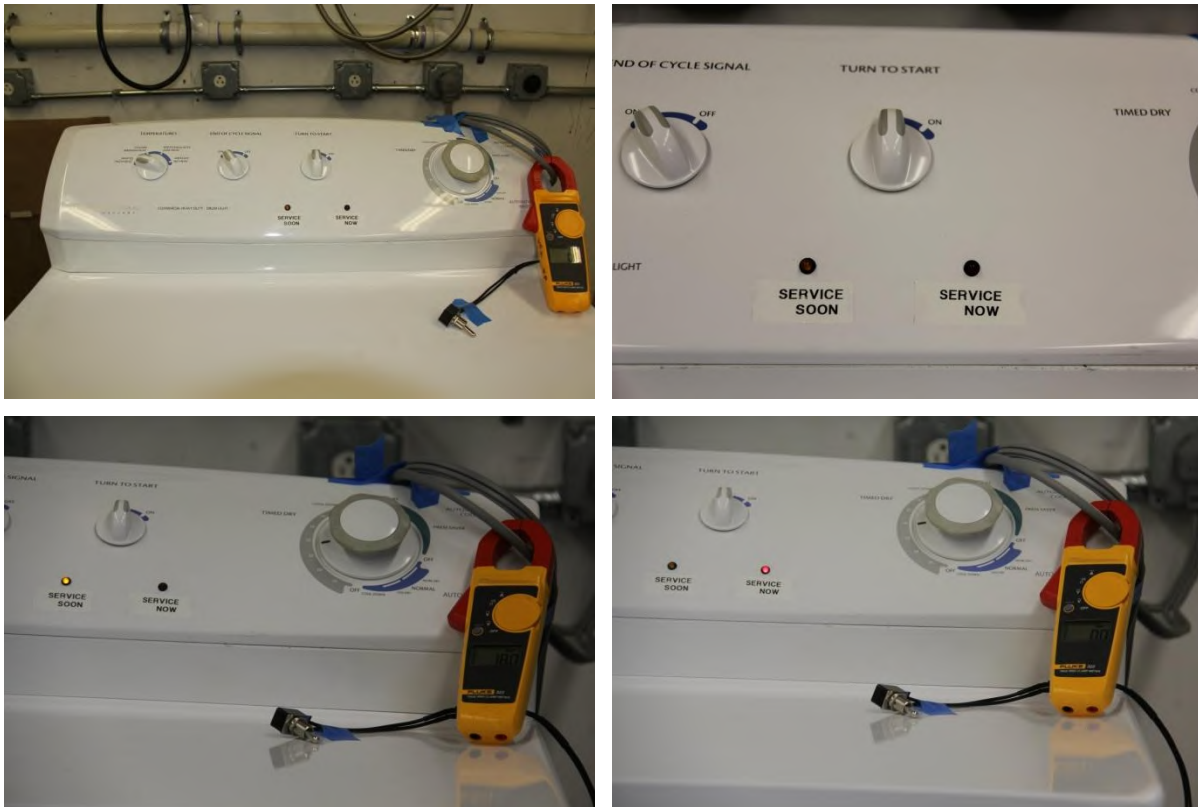
This maintenance reminder safeguard was incorporated into a dryer we refer to as RONCO 5, being the 5th clothes dryer we have implemented and tested an alternative design or safeguard within. RONCO 5 is a working Electrolux electric ball-hitch clothes dryer (Model: GLER341AS1) that was tested with wet towel loads and not one failure of the maintenance reminder safeguard occurred during the testing, indicating that it was 100% reliable. The

maintenance reminder safeguard was tested for over 50 cycles, which is the equivalent of 75 years of life if it were to be programmed as an 18 month equivalent reset counter. Furthermore, since this safeguard is electronic in nature it has a long life expectancy; the relay used to deactivate the heater is rated to a minimum service life of 100,000 cycles. A video of a testing cycle was recorded on the RONCO 5 dryer to demonstrate the functionality of the maintenance reminder safeguard.

RONCO 5 Maintenance Reminder Safeguard Testing

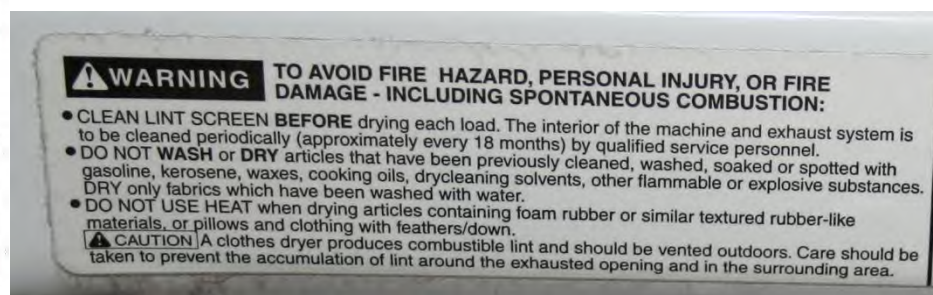
The warning label is installed on the right side of the drum opening and is visible to the user when the door is open. The warning on the dryer does not warn against the fire hazards associated with lint collecting behind the drum at the heat source. This warning label only instructs to “exhaust the dryer to the outdoors”, and to “prevent the accumulation of lint around the exhaust opening and in the surrounding area”. The only other maintenance instructions regarding the exhausting of the appliance and prevention of lint accumulations within the appliance on the warning labels or visible on any of the component parts is to “Clean lint screen before or after each load.” The Electrolux stand-alone dryers do not contain any warnings as to having the dryer serviced every 18 months, though their laundry centers, the combination washer/dryer unit, do have a warning label at the drum opening with those instructions. This inconsistency demonstrates Electrolux’s failure to provide consistent warning as to the maintenance methods they deem important as to the prevention of fires. Both labels are included below:

Warning Labels from Standalone Dryer (Left) & Laundry Center (Right)
